The Sutton Historical Society restoration project for Sutton Center Cemetery started in August of 2019 and was completed in July of 2022. Below are before and after photos of the Sibley family obelisk that was one of 384 stones that were cleaned.

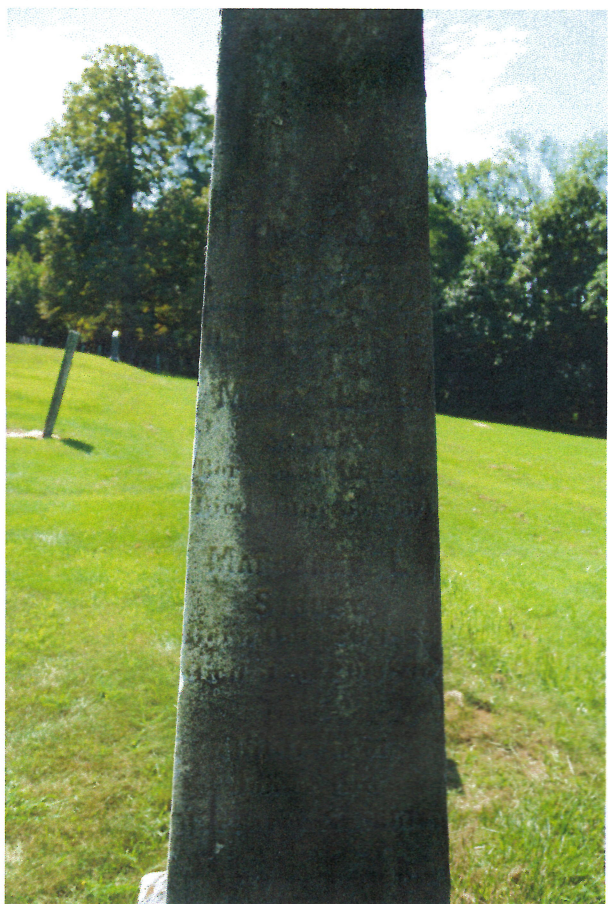
As found – north side

Mold, lichens and moss are the vegetation commonly found on the surfaces of all stones. Mold, in particular, fouls the more porous surfaces of weather-worn marble and brownstone.

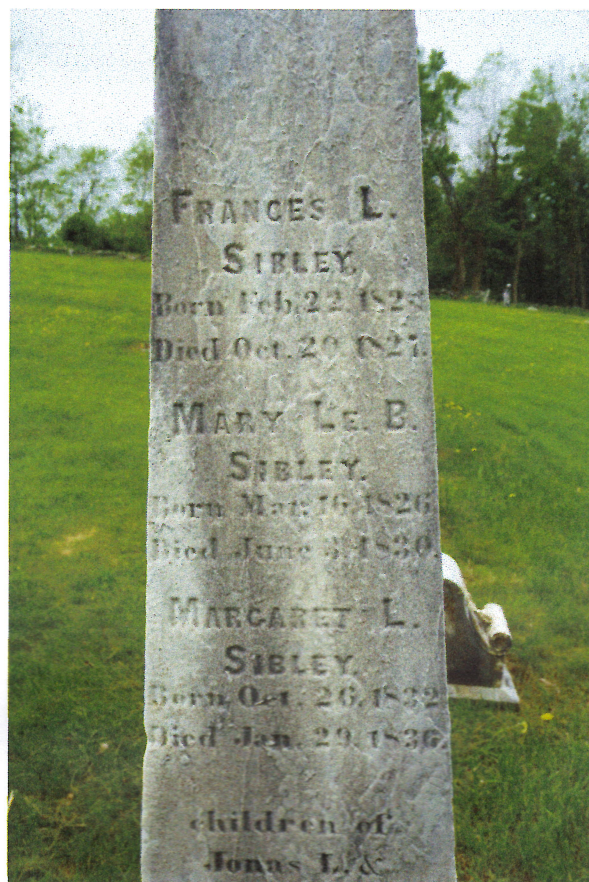
After cleaning

After wetting and scraping to remove the lichens and mold, this obelisk was sprayed with D/2 cleaner. After a few minutes of contact time, the surfaces were well brushed with a plastic brush and thoroughly rinsed. No metal scraper or metal brush was used as these can permanently damage the surfaces.

The still gray tone surfaces were then left to let sunlight finish the process.

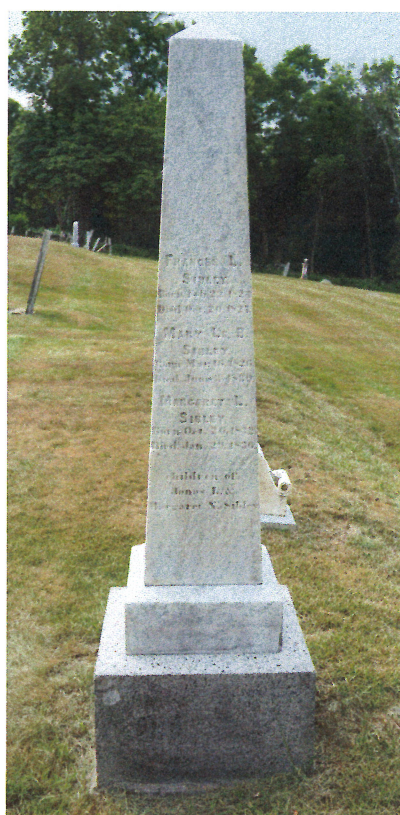
One year later
North side that receives no
direct sunlight

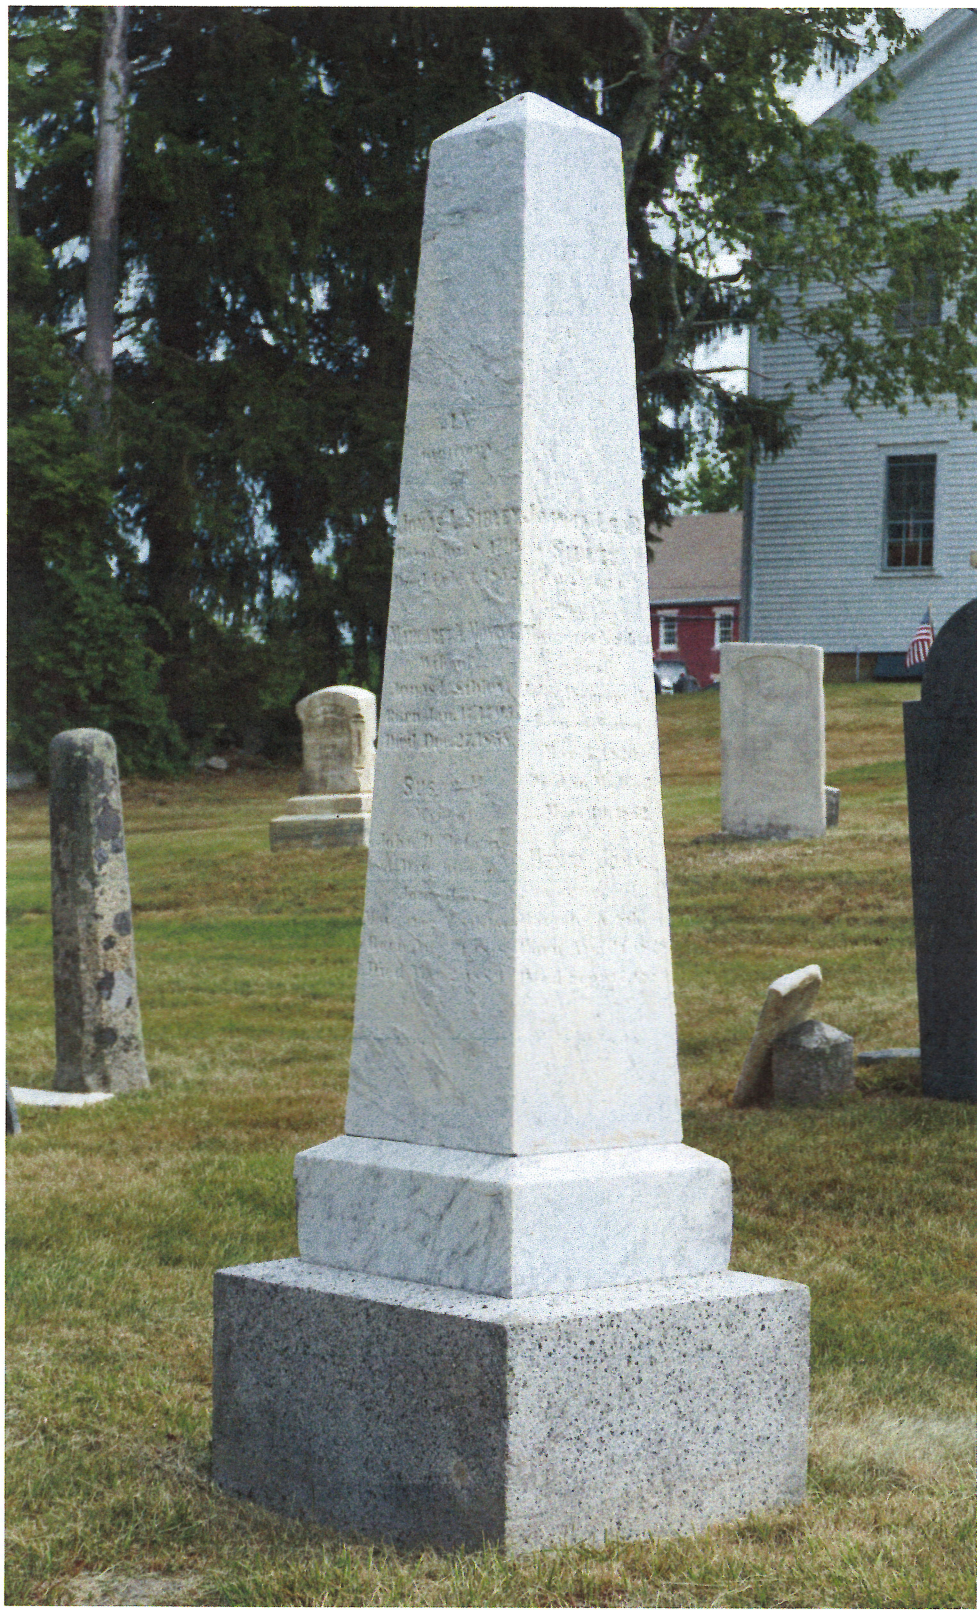
South and west sides that receive direct sunlight
